ASBESTOS SURVEY FOR FORT POINT U.S. COAST GUARD STATION

Presidio of San Francisco

**Prepared by:
R.L. Stollar & Associates, Inc.
Urie Environmental Health, Inc.**

September 1991

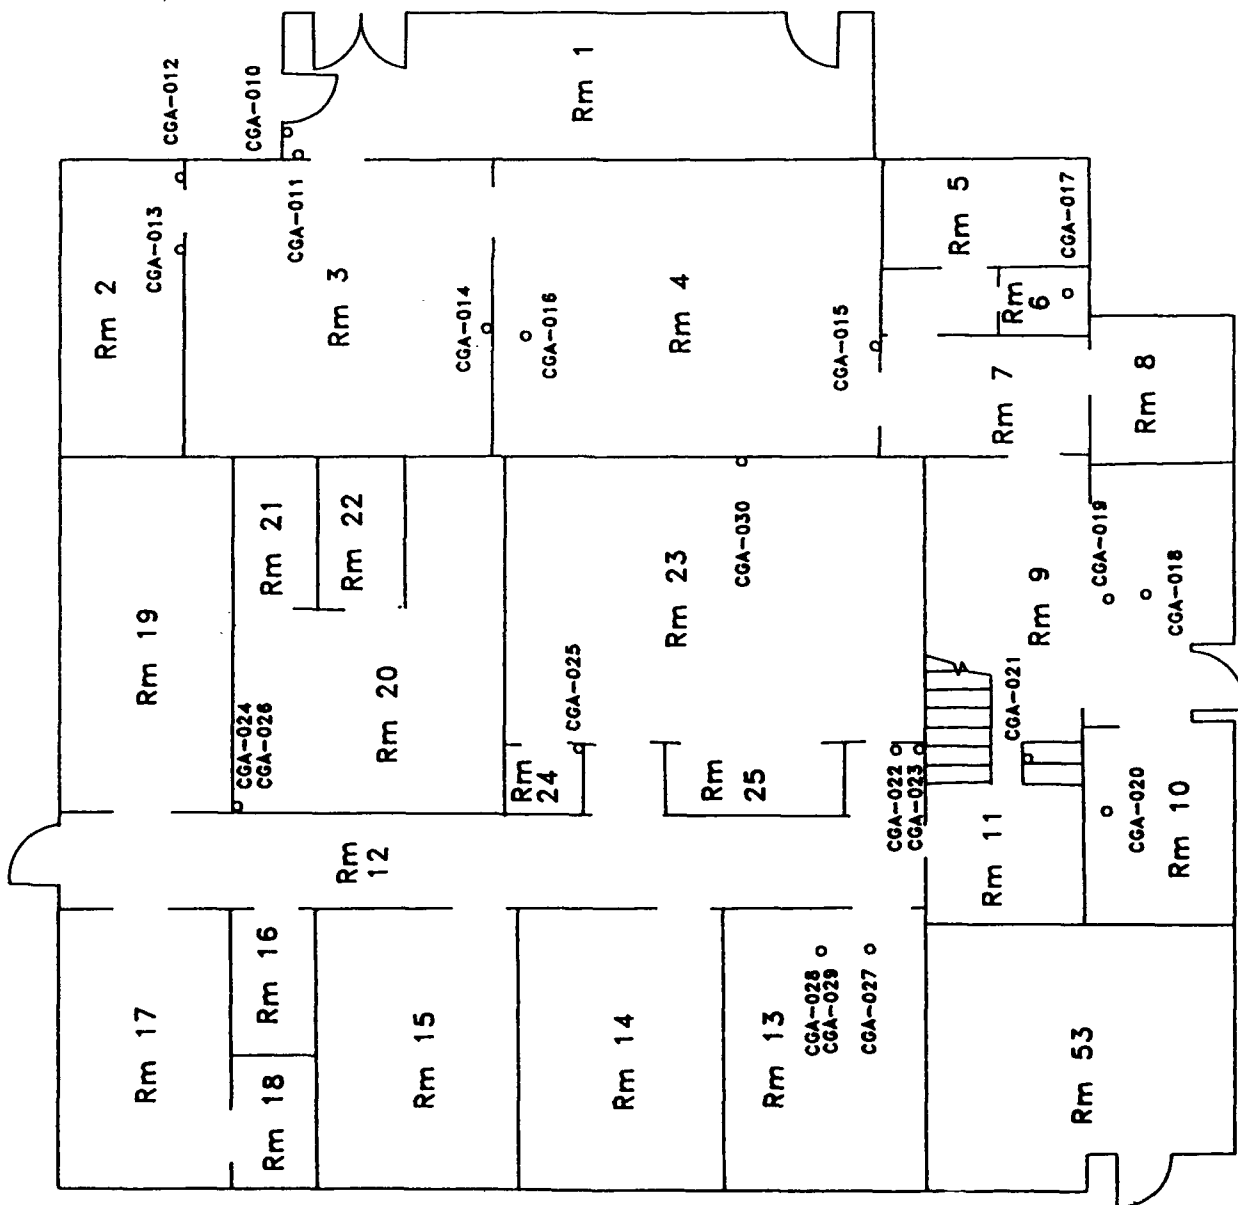
Figure 3.1-1

Building 991 is the former station house, a four-story, wood-frame structure with wood shake siding and roof, and has been recently reoccupied. A total of 75 functional areas including 55 rooms and closets, one crawl space, and 19 functional areas above ceiling panels were inspected. A total of 37 samples were collected, including 15 friable (table 3.1-1) and 22 nonfriable (table 3.1-2) samples, and sent to Versar for analysis. Figures 3.1-1 through 3.1-4 illustrate room and sample locations on each level. None of the friable samples collected tested positive for asbestos while one nonfriable sample tested positive. This sample, CGA-032, was a piece of linoleum floor material from the laundry room (Room 28, figure 3.1-2) and it contained 20 to 25 percent chrysotile asbestos. This particular type of floor material was found only in Room 28.

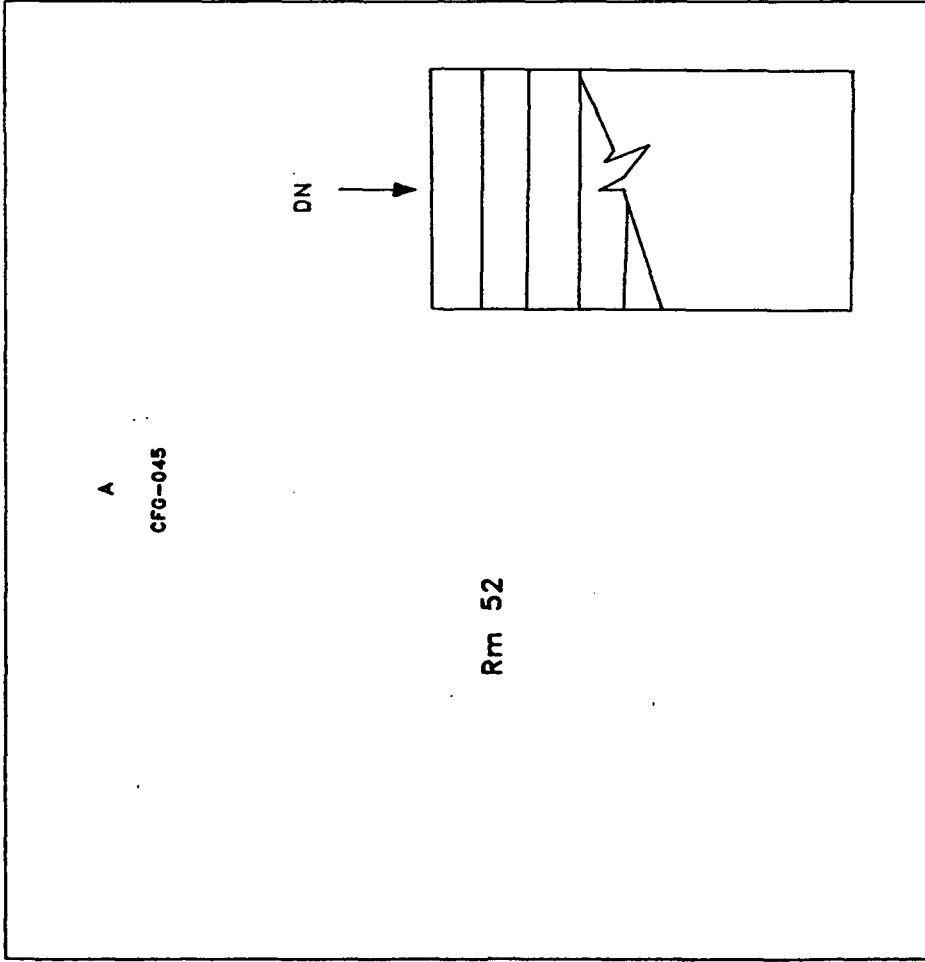
Figure 3.1-4

FLOOR PLAN & SAMPLE LOCATIONS
BLDG 991, LOOKOUT TOWER
FT. POINT U.S. COAST GUARD STATION
ASBESTOS SURVEY

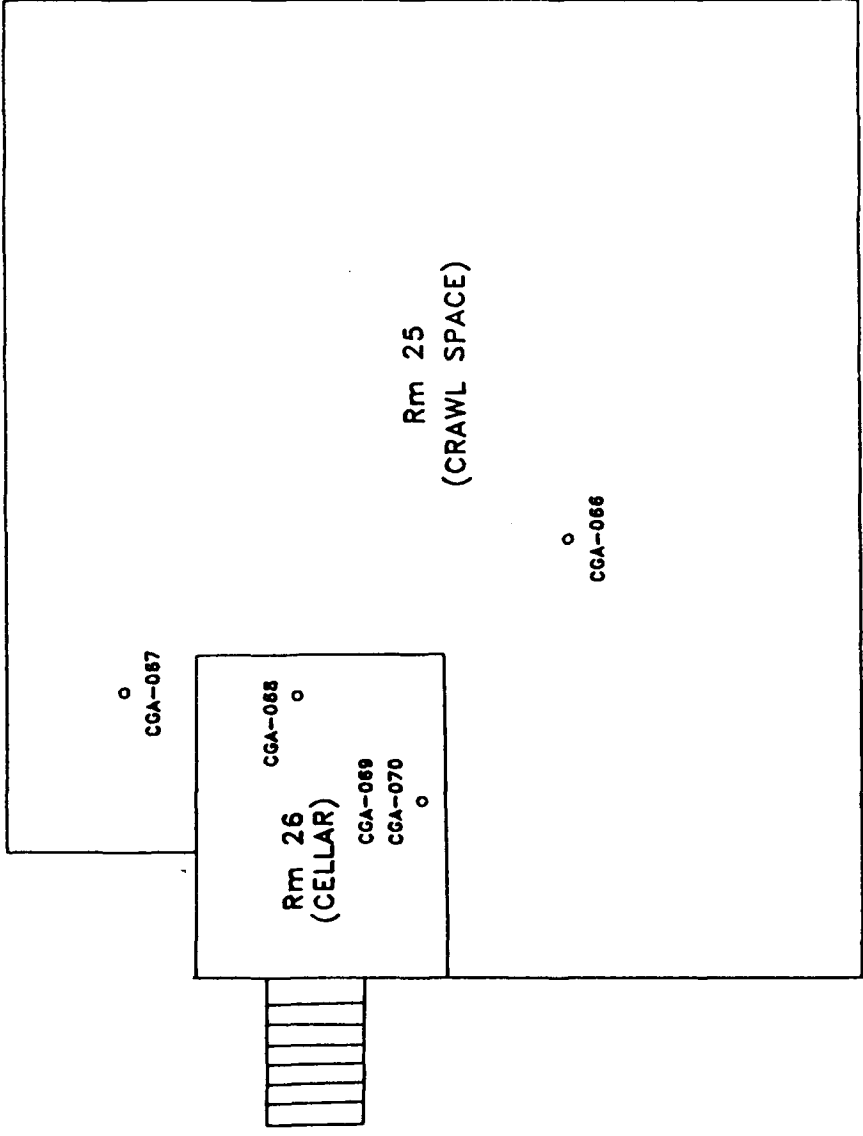
Date: July 1991 Figure 3.2-1

Building 992 is the Officer in Charge's (OIC's) residence, a two-story, wood-frame structure with wood shake siding and roof. A total of 29 functional areas including: 23 rooms and closets, one cellar, one crawl space, one attic, two functional areas above a false kitchen ceiling and a bedroom closet, and one enclosed stairwell used as an air plenum were inspected. A total of 21 samples were collected, 18 friable (table 3.2-1) and three nonfriable (table 3.2-2), and sent for analysis. Figures 3.2-1 through 3.2-4 show room and sample locations for each level. Five of the friable samples tested positive while none of the nonfriable samples tested positive for asbestos.

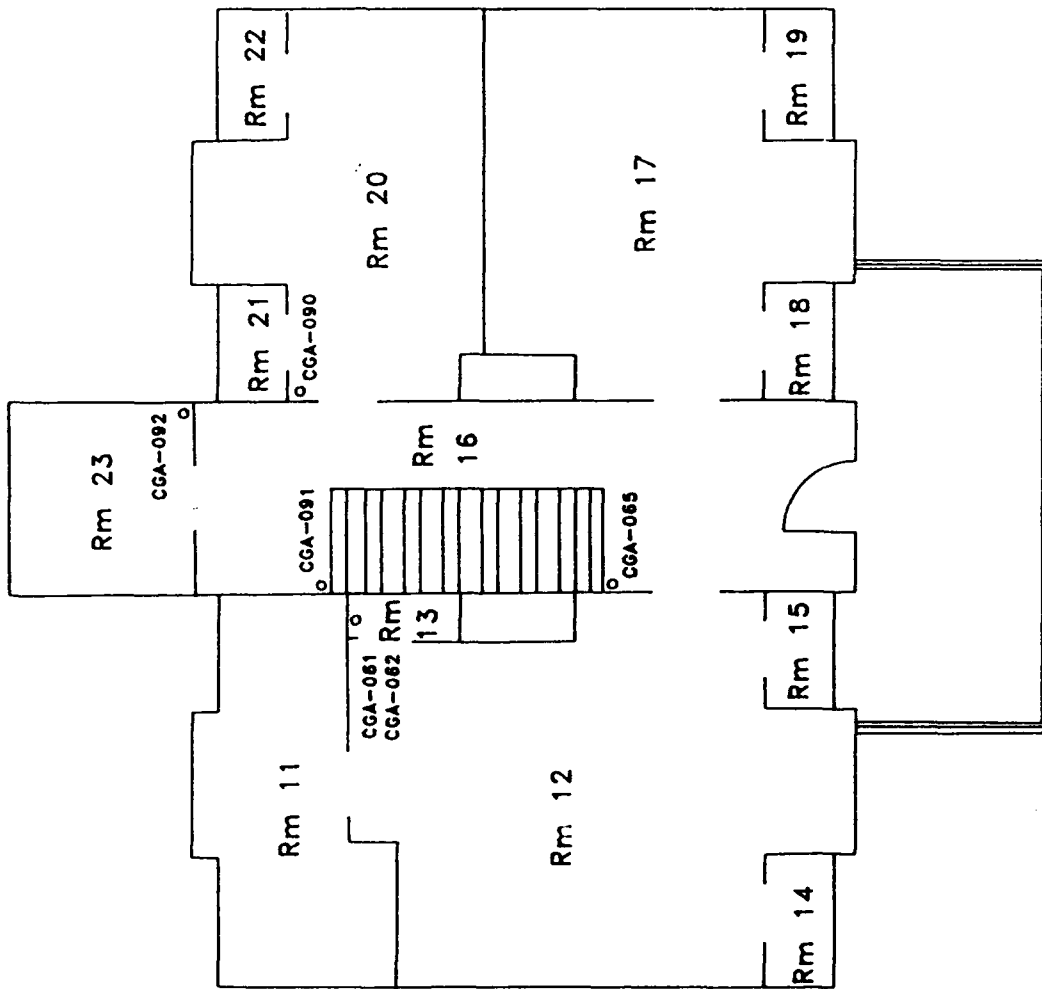
Figure 3.2-3

Sample CGA-065, collected on the second floor in Room 16 (figure 3.2-3), contained plaster which is present on the walls and ceilings of many of the rooms in the house. The sample also contained joint compound which is locally present around electrical fixtures. Analysis indicates 1-5 percent chrysotile asbestos in this sample. Asbestos was contained entirely within the joint compound while

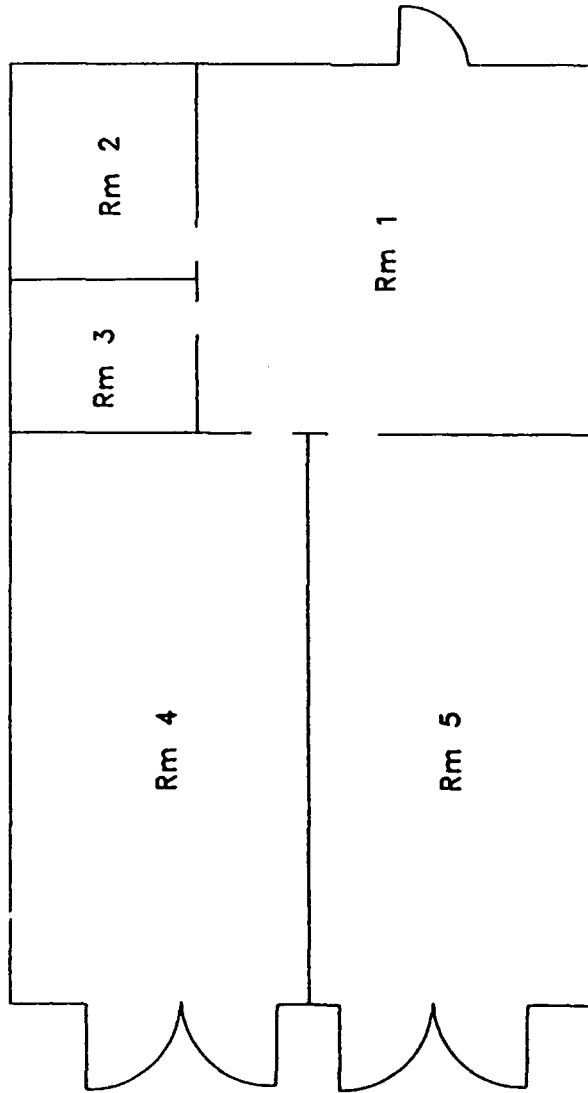
Figure 3.3-1

Building 993 is the OIC's garage, a one-story, wood-frame structure with wood shake siding and roof. No suspect ACM were observed during inspection of this building; therefore, no samples were collected. Figures 3.3-1 and 3.3-2 illustrate the layout of the garage and its attic area.

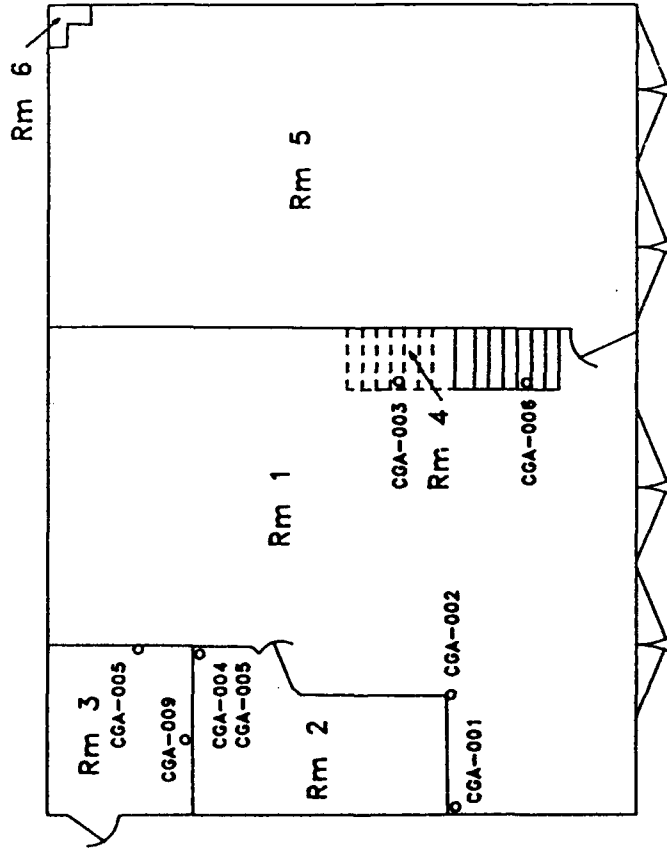
FLOOR PLAN & SAMPLE LOCATIONS
BLDG 995, FIRST FLOOR
FT. POINT U.S. COAST GUARD STATION
ASBESTOS SURVEY

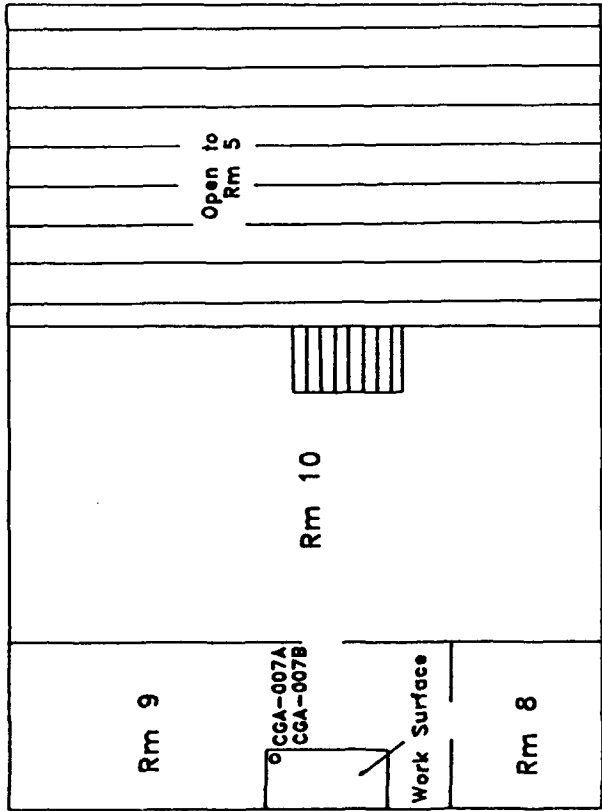
FLOOR PLAN & SAMPLE LOCATIONS
BLDG 995, ATTIC
FT. POINT U.S. COAST GUARD STATION
ASBESTOS SURVEY

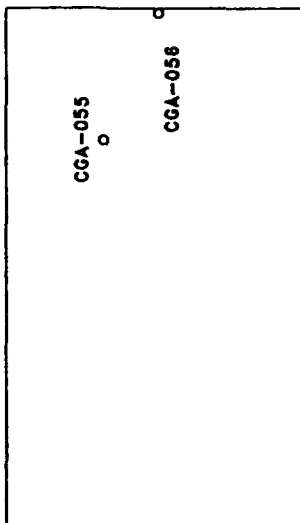
FLOOR PLAN & SAMPLE LOCATIONS
BLDG 997
FT. POINT U.S. COAST GUARD STATION
ASBESTOS SURVEY

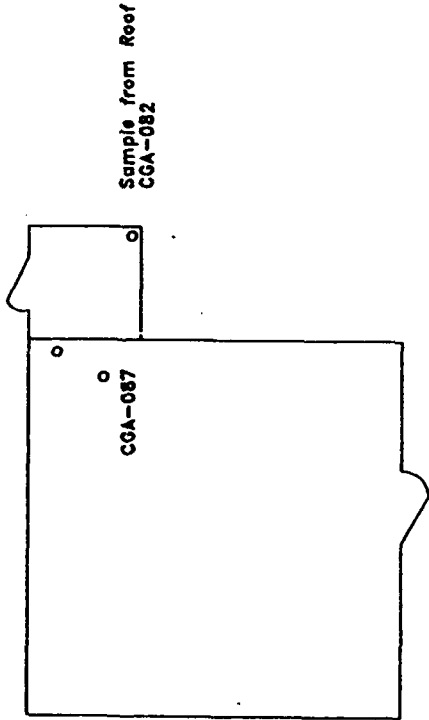
Samples from Roof
CGA-083
CGA-084
CGA-085
CGA-086

FLOOR PLAN & SAMPLE LOCATIONS
BLDG 899
FT. POINT U.S. COAST GUARD STATION
ASBESTOS SURVEY
